## **U.S. 101 MP 111.34 Unnamed Tributary to Stevens Creek (WDFW ID: 990731) Preliminary Hydraulic Design Report**

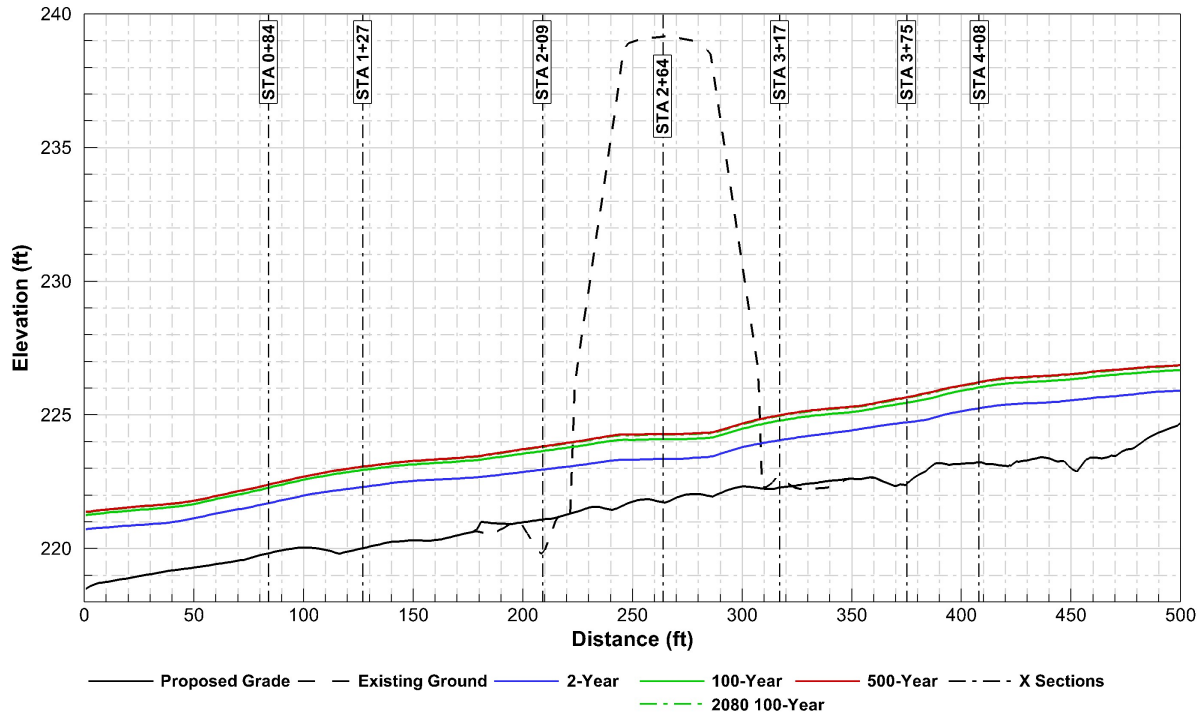
Figure 42: Proposed-conditions water surface profiles

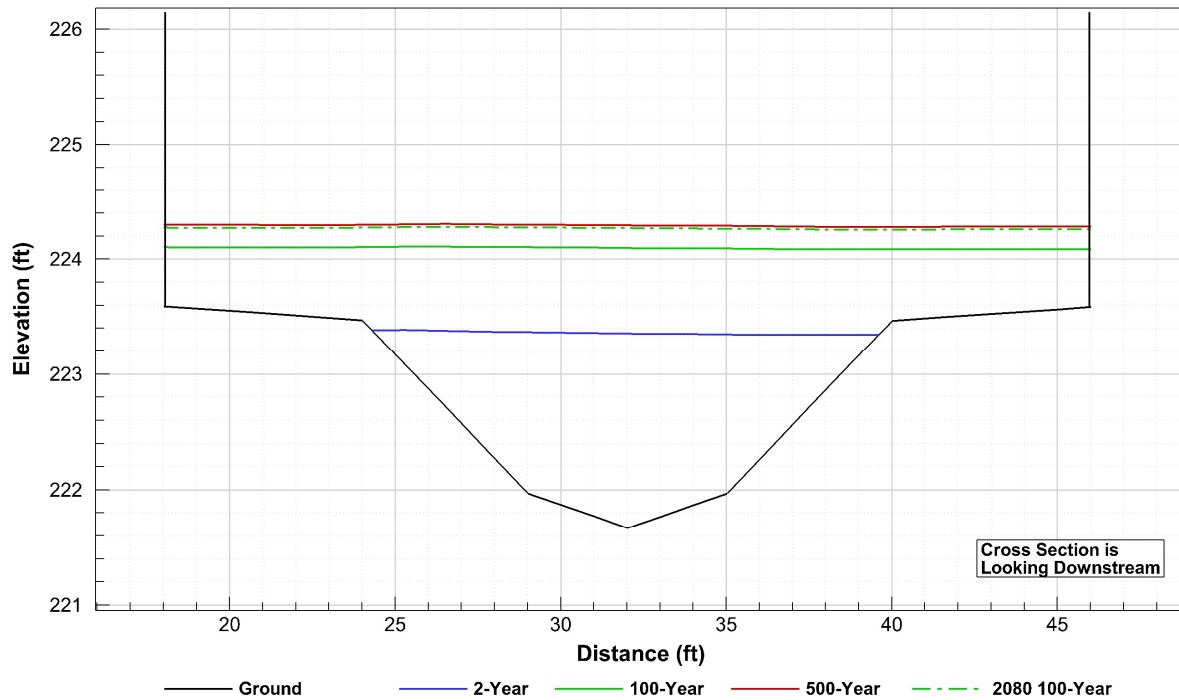
Figure 43: Typical section through proposed structure (STA 2+64)

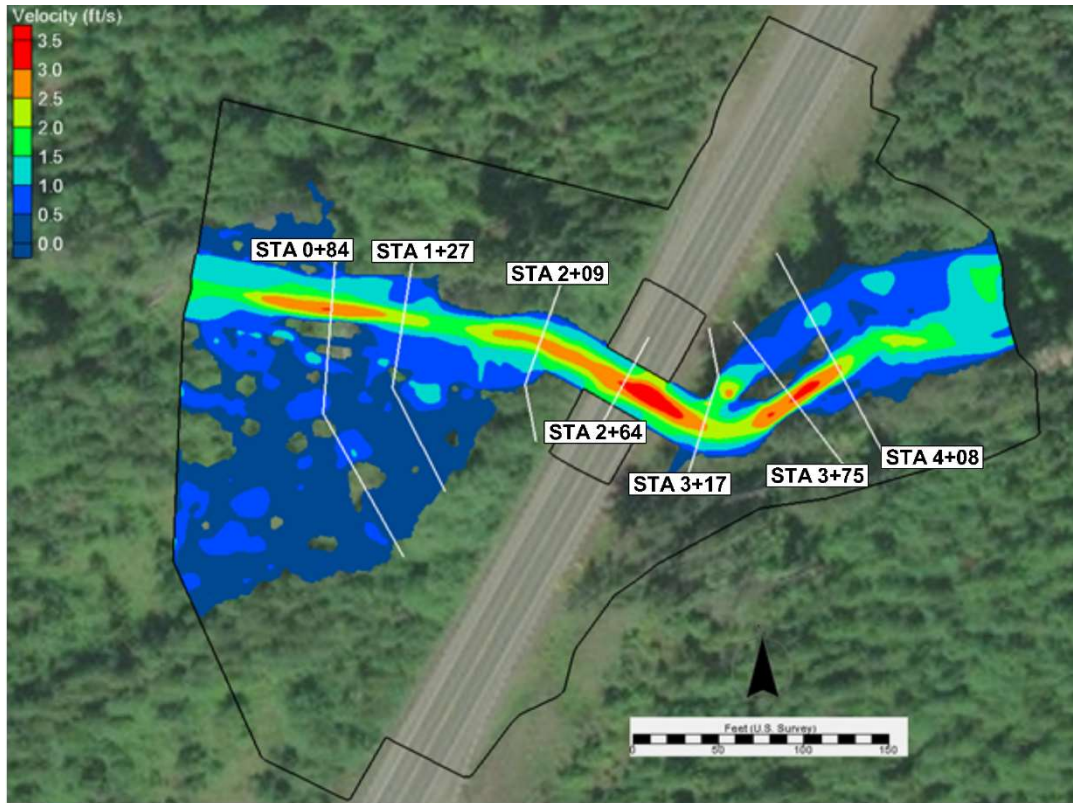
Figure 44: Proposed-conditions present day 100-year flood peak velocity map

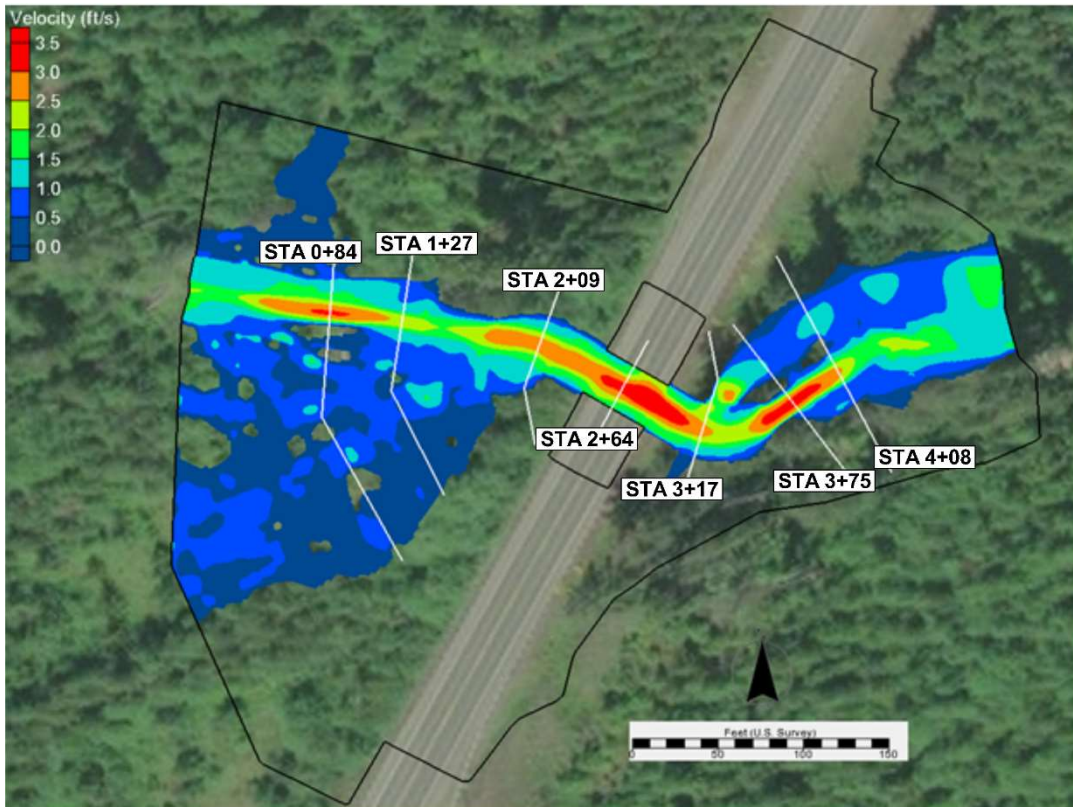
Figure 45: Proposed-conditions 2080 predicted 100-year flood peak velocity map

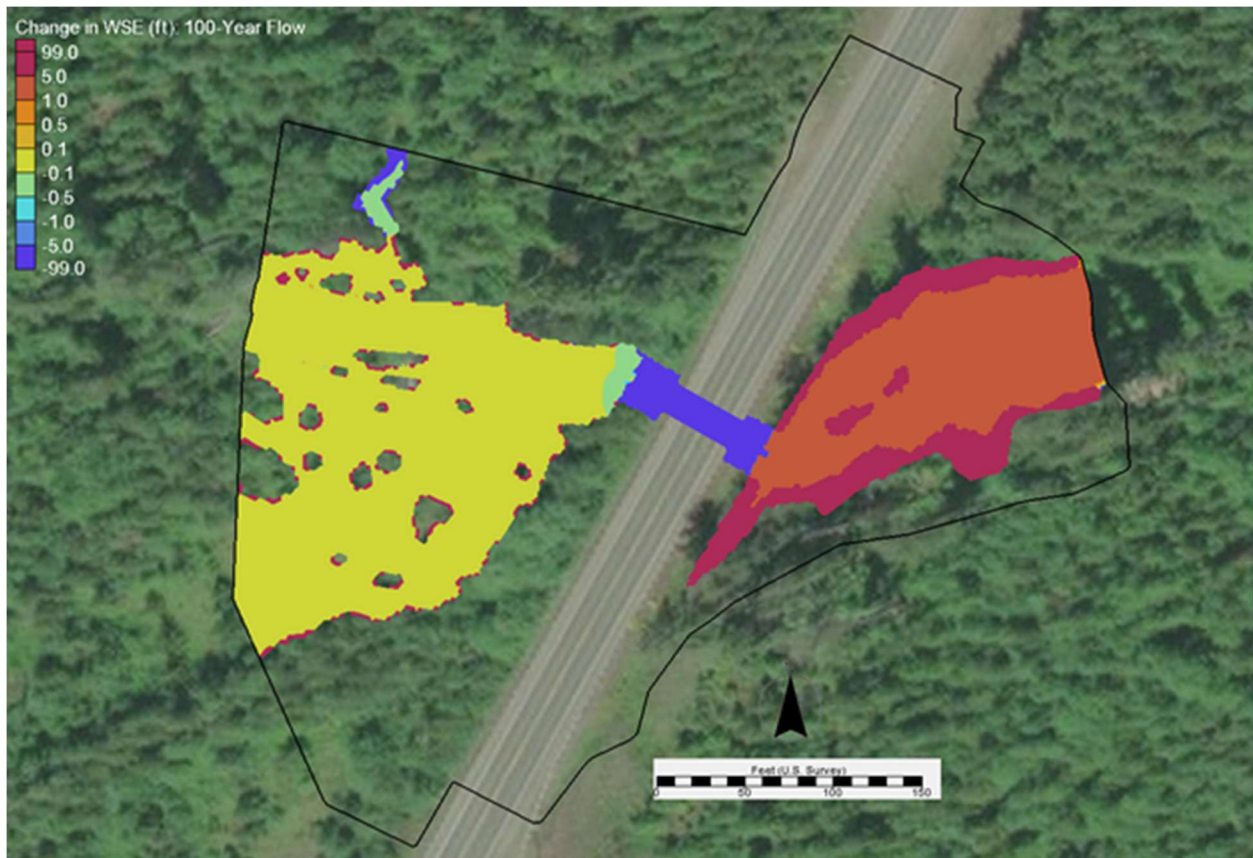
Figure 49: Map of water surface elevation changes (existing minus proposed) with a replacement structure

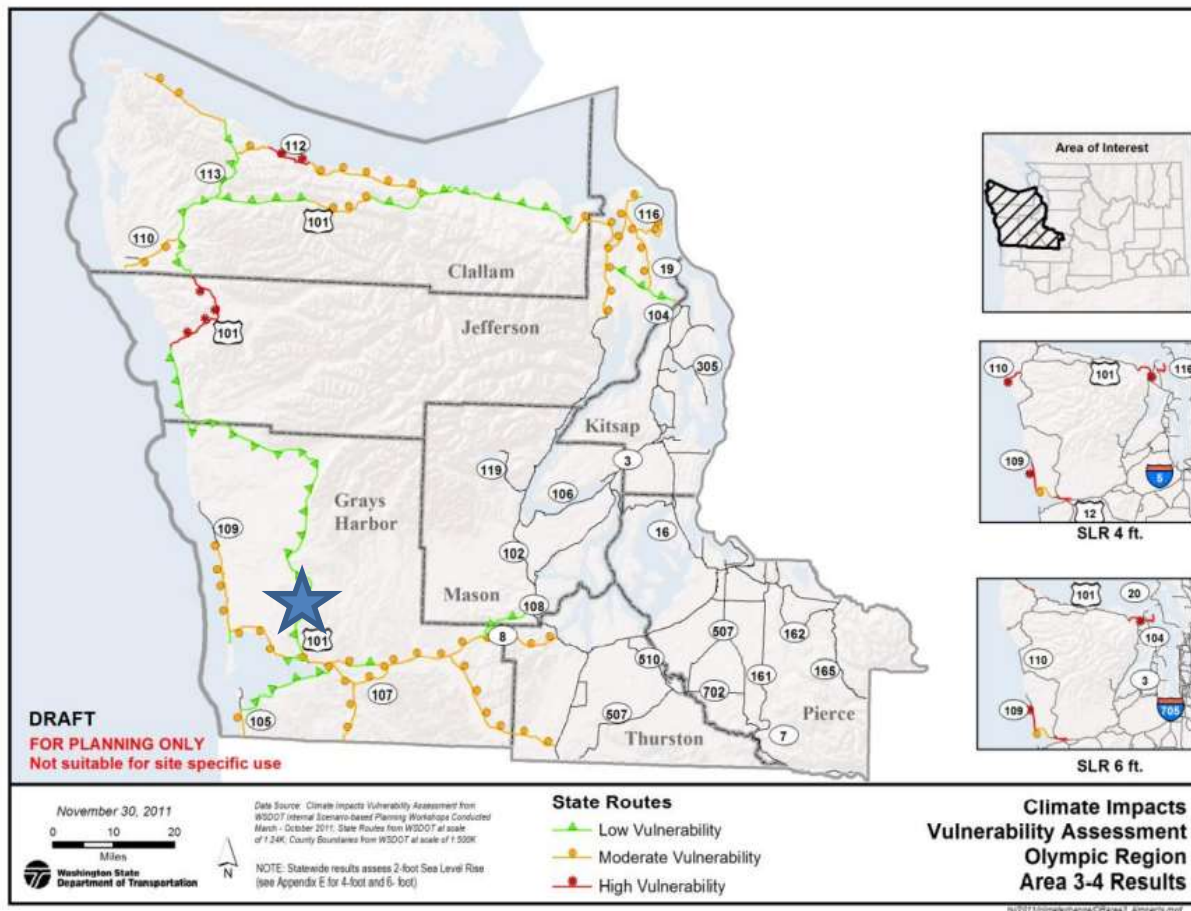
Figure 50: Climate impacts vulnerability assessment of Olympic Region areas 3 and 4 (source: WSDOT 2011). Site location is indicated by star

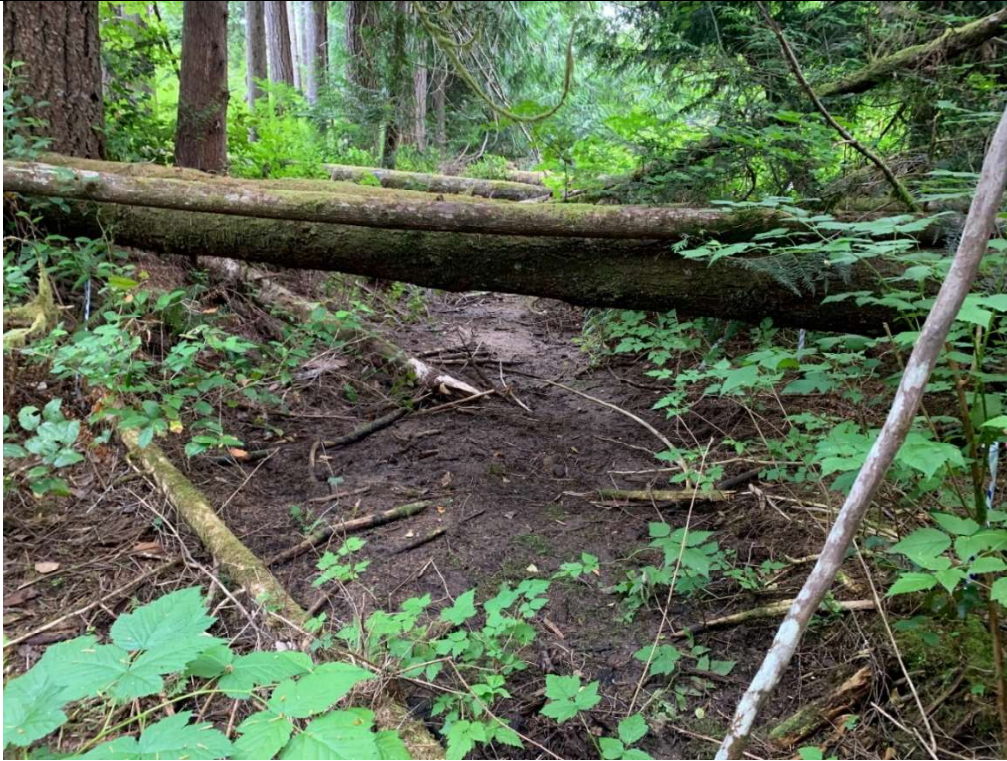
Photo 3: 600 ft upstream of SR 101, looking upstream: No flow, channel narrows, full of wood debris, LD fallen trees are well above the channel.
